Task Order 2 Enhanced Preliminary Assessment

KAPALAMA MILITARY RESERVATION
HONOLULU, HAWAII

February 1990

ENHANCED PRELIMINARY ASSESSMENT REPORT

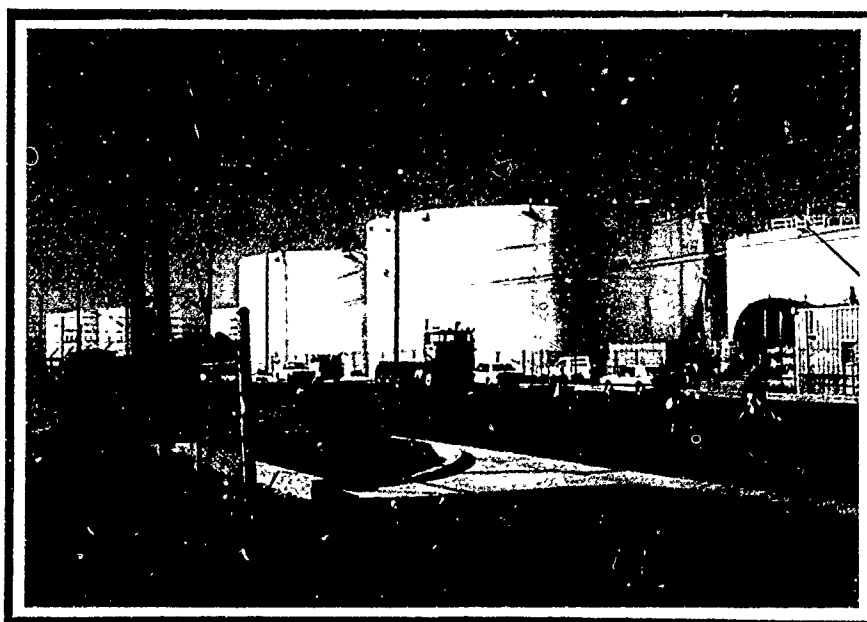
8. Chevron Tank Farm

Piers 39 and 40 are owned by the State of Hawaii. Fuel oil and diesel fuel lines have been run to both piers, crossing Nimitz Highway to the northeast of KMR. Underground leaks from these pipe lines or from the tank farm could potentially migrate to KMR. The direction of potential leaks from any of these sources is not certain because this is an area of tidal groundwater fluctuation.

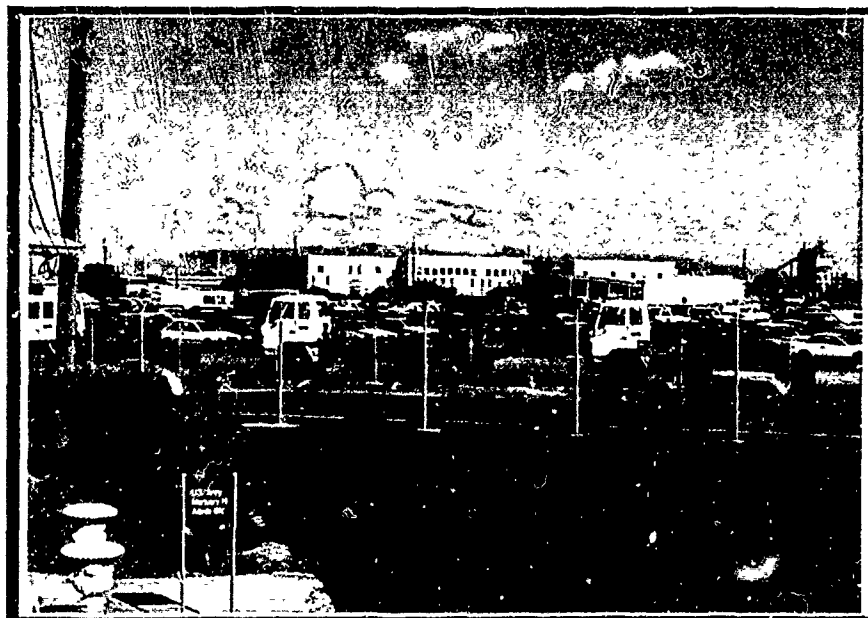
10. Car/Truck Storage Area

The Phase I portion of the property that is now owned by Servco Pacific, Inc., is currently used for the storage of automobiles and trucks.

This property reportedly contained three underground storage tanks, at least one of which was removed prior to sale of the property by the Army. The tanks contained diesel oil and gasoline; their sizes and dates of installation are unknown. According to a 1987 report, a pressure test indicated one of these tanks was leaking [R-1]. Information recently received from the Department of Logistics at Kapalama indicated that subsurface hydrocarbons were found under the Phase I property [I-2]. Borings have been drilled by Dames & Moore and have revealed hydrocarbons in at least two borings to date [Appendix B]. Dames and Moore also conducted a soil gas survey and reported a "small area" as having measurable quantities of soil gas near the surface zone. A report by Woodward-Clyde Consultants also indicated the presence of subsurface hydrocarbons [R-7; Appendix B].

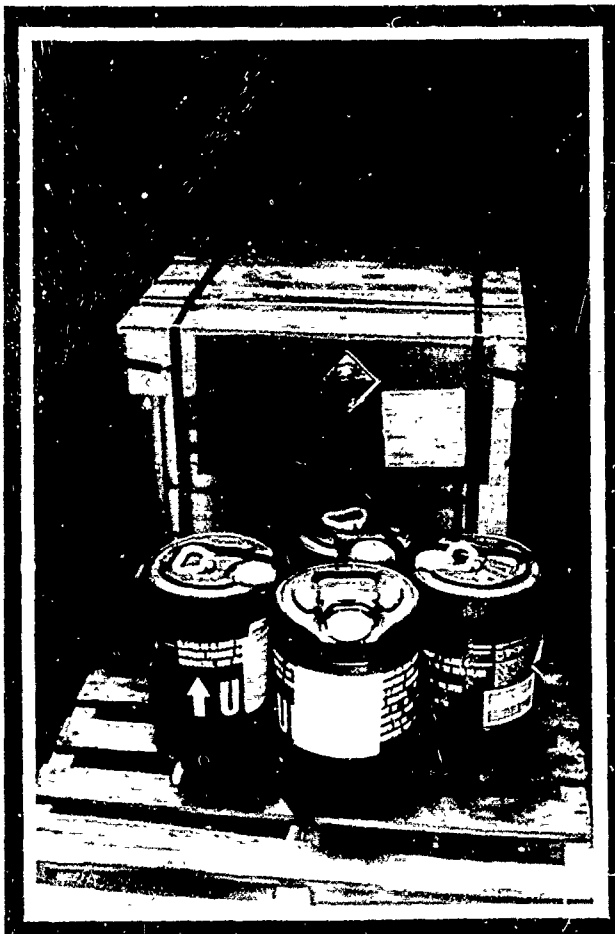
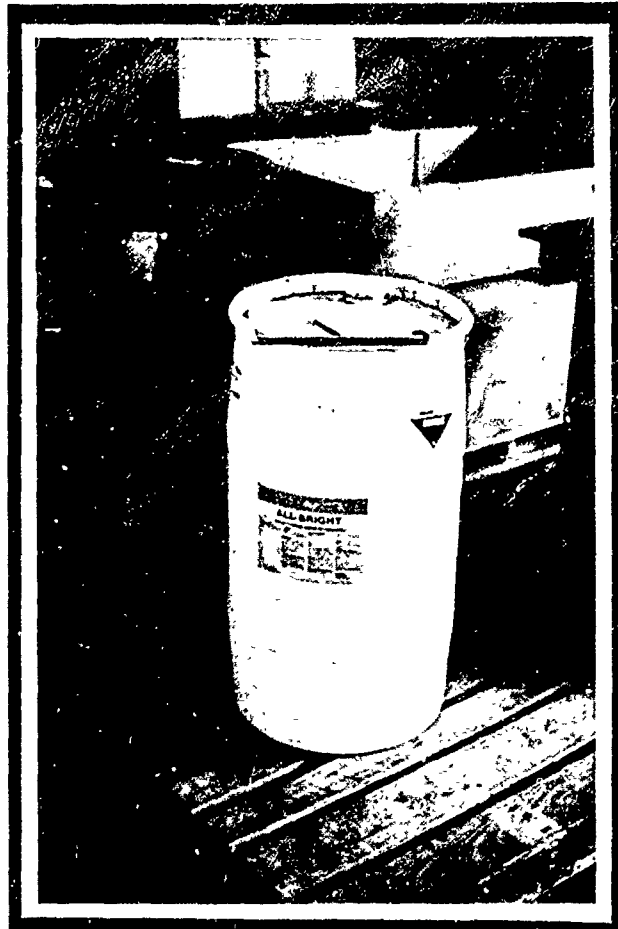
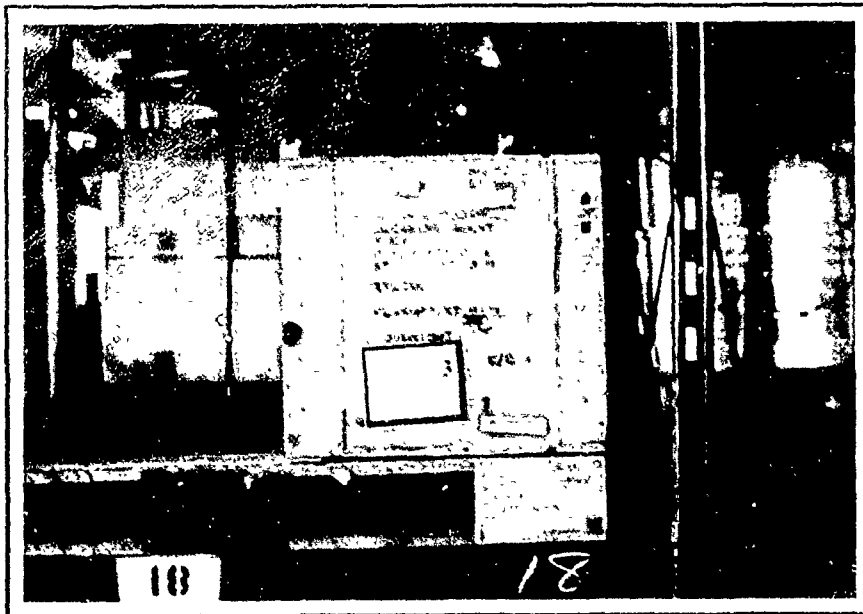
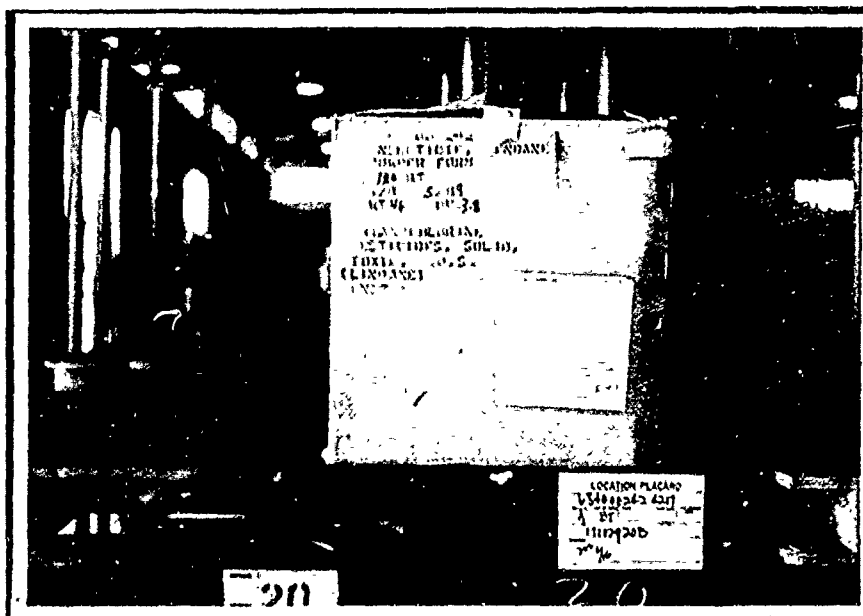
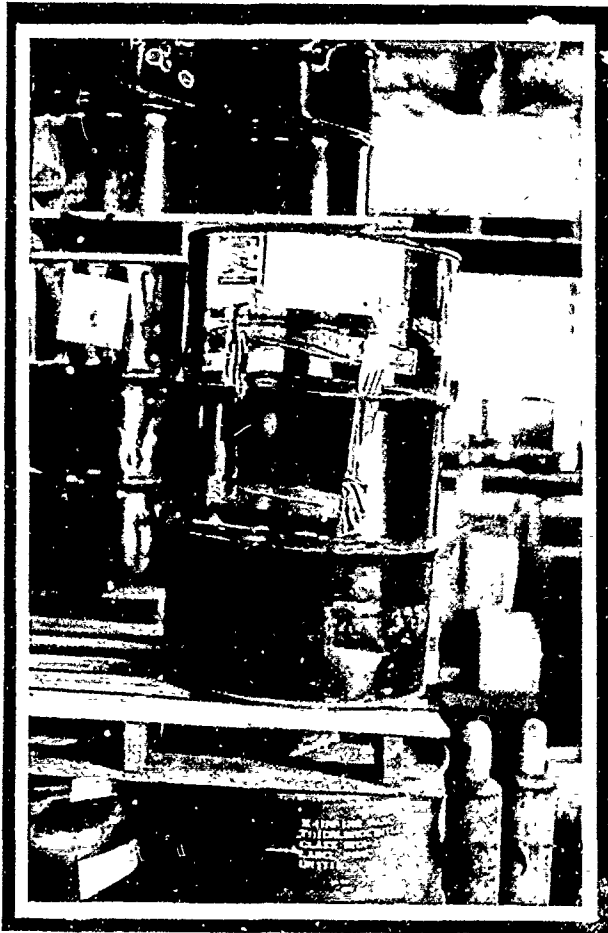
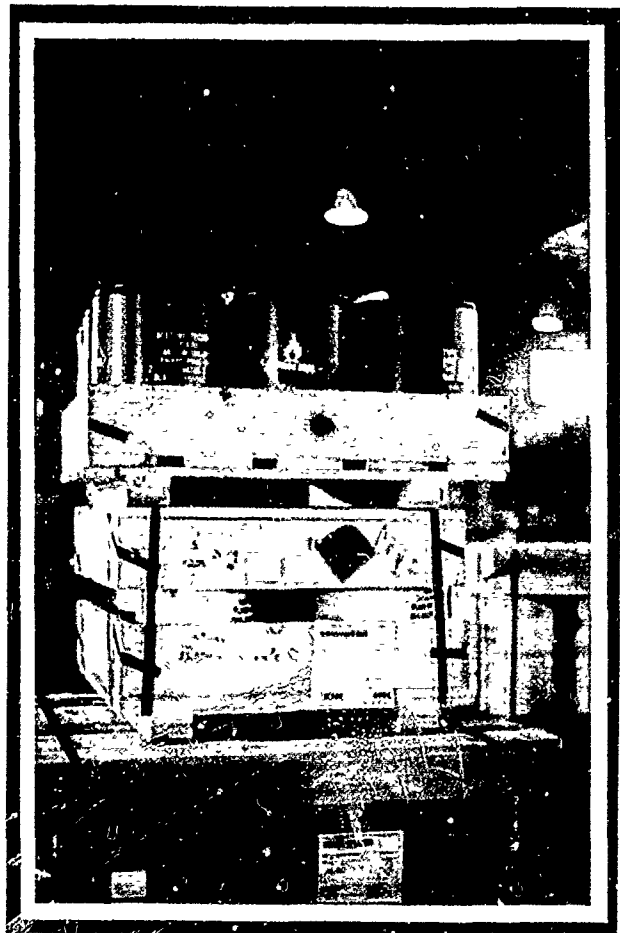
CONTENTS OF BUILDING 917

The chemicals are stored on wooden pallets and/or metal shelves and racks, and no secondary containment is provided. The warehouse floor is concrete and marbled with cracks, some as large as 1/4 in. Any spills that may have occurred were washed out of the building into the storm drain in the parking area between the buildings. There are no floor drains in the building.

Any hazardous chemicals that were spilled could have entered cracks in the floor and remained there after surface cleanup was complete. It is not known how far into the slab these cracks penetrate or if any subsurface contamination has occurred.

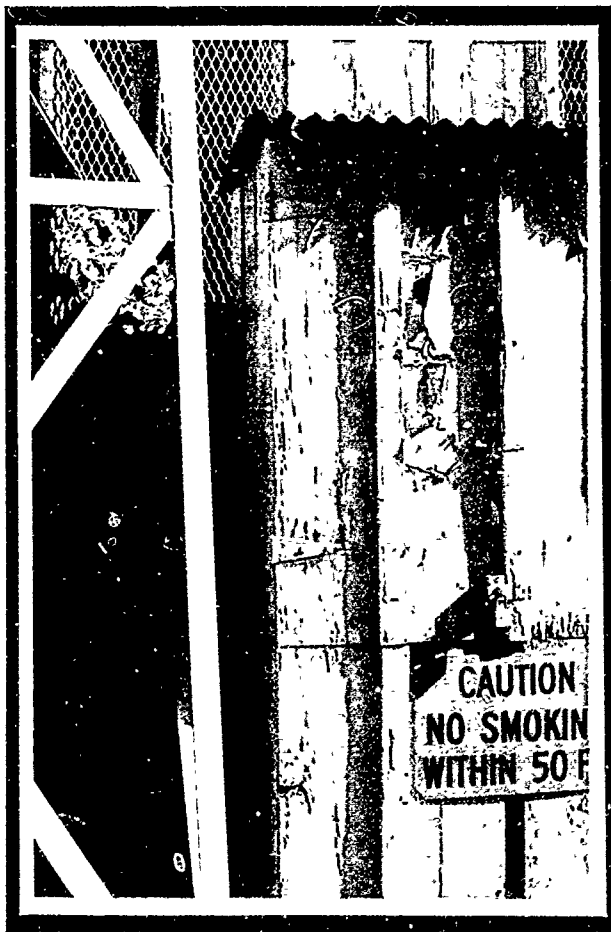
20. DRAIN LEADING TO DRUM IN SHED

Two storage areas that contain hazardous materials and waste liquids are adjacent to Building 923. One area consists of racks containing 55-gal drums filled with fresh solvents such as paint thinners and chlorinated degreasing solvents. The other site is a wire-fenced area in which 55-gal drums of waste solvents from the paint booth and degreasing areas are stored on wooden pallets. Both of these drum storage areas are on the asphalt-paved area near the property perimeter fence along Sand Island Road (photos 22 and 24). Waste solvents and oil are transported by private contractor to Schoefield Barracks for disposal. There are no containment dikes of any type at either storage area. Both storage areas drain to the storm sewer system.

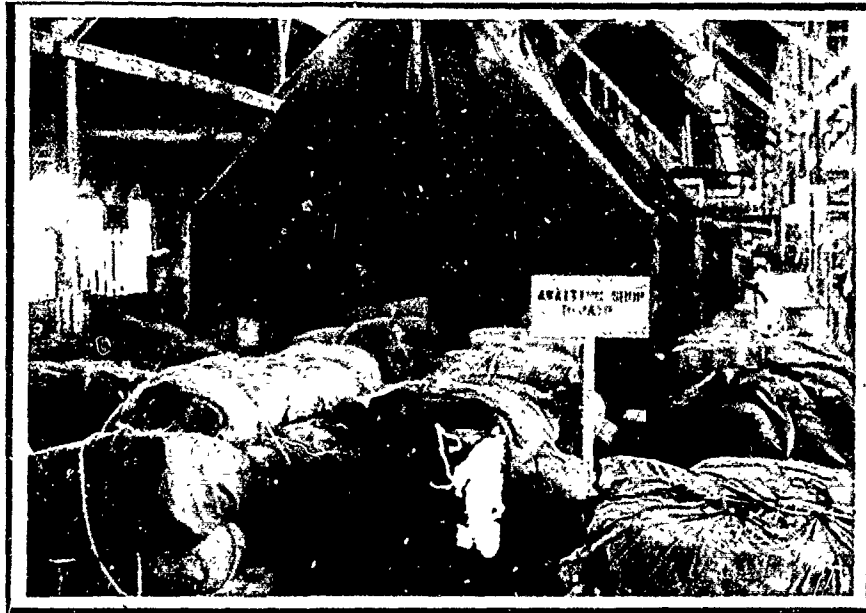
CANVAS REPAIR AREA, BUILDING 924

- Building 924 - Canvas Repair Area & Packaging Area - waterproofing with polymer-type water repellents; packaging with isocyanate foam; "waste oil" drums (apparently empty) on pallet outside building.

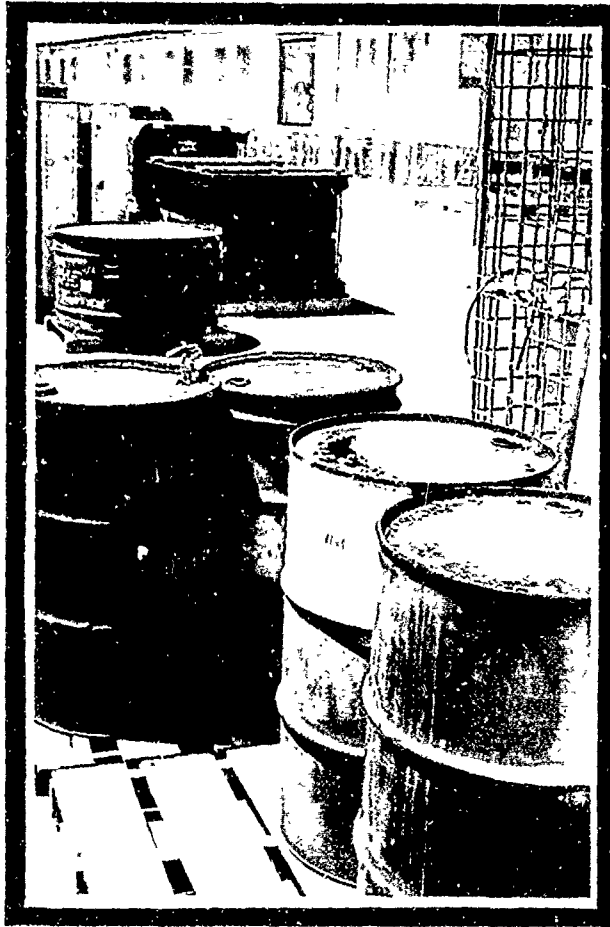
29. RUSTED DRUMS OUTSIDE BUILDING 924

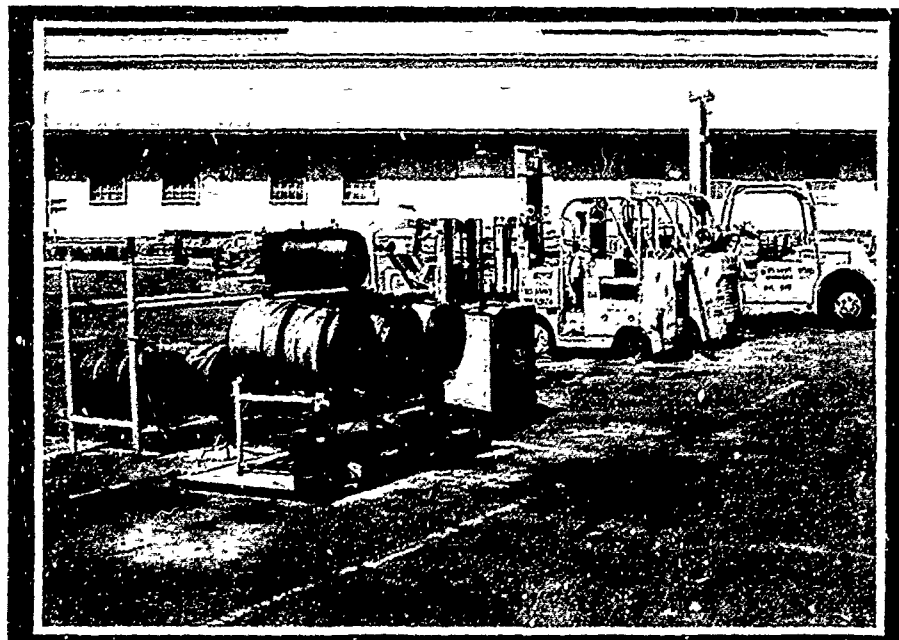
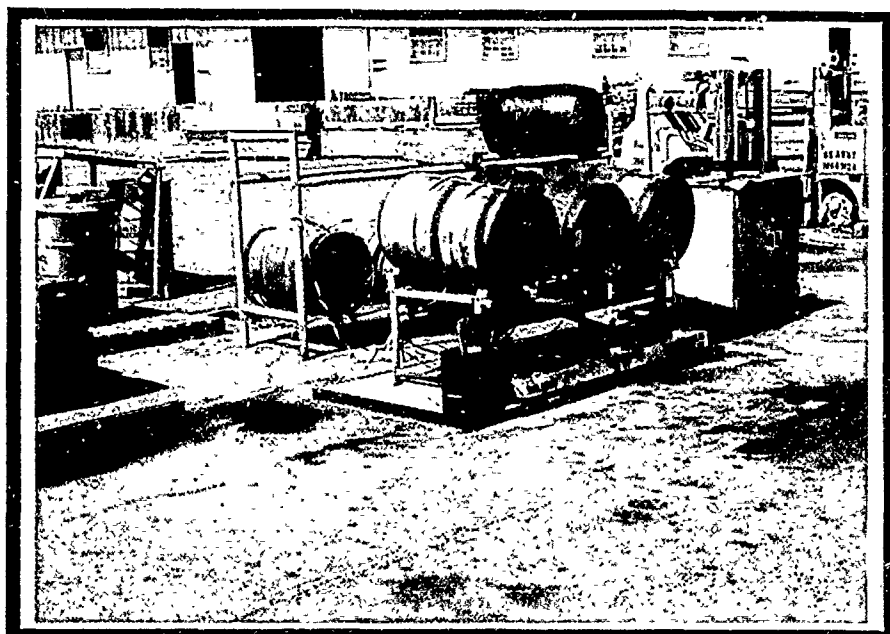
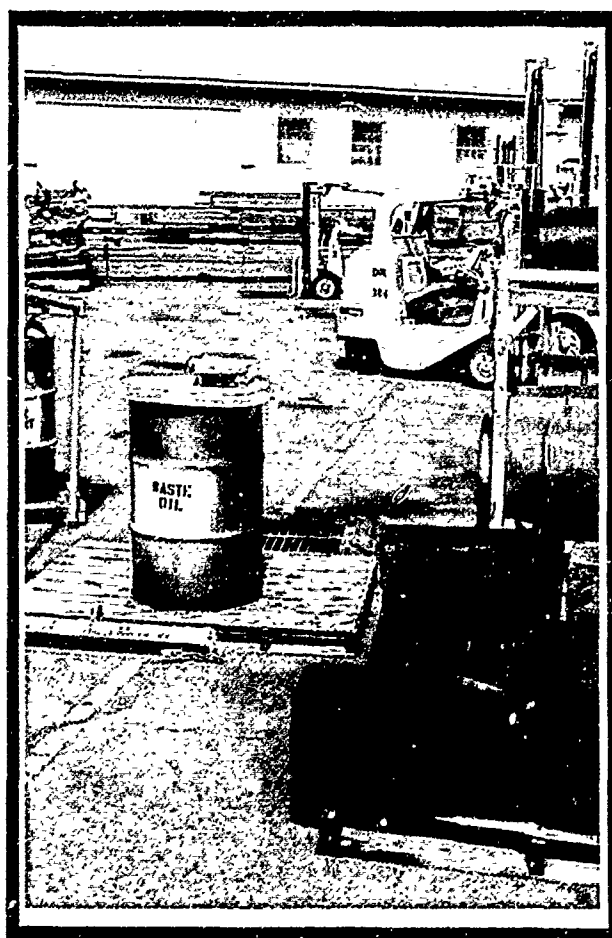
30. FORK LIFT MAINTENANCE AREA, BUILDING 925

- Building 925 - Maintenance & Repair of Forklifts - oils, greases, solvents, and hydraulic fluids used in the repair and maintenance of forklifts in an area adjacent to the building.

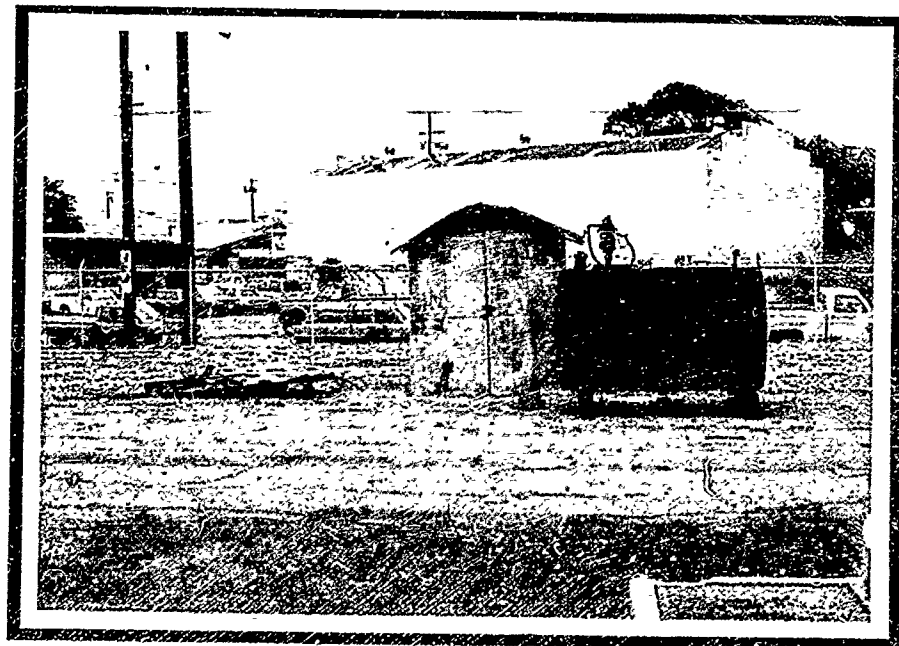
40. KEROSENE STORAGE TANK

- approximately 300-gal kerosene tank adjacent to a grassy area.
 - 5,000-gal propane tank adjacent to Building 925.
 - 500-gal propane tank adjacent to Building 921 reported by personnel but not observed during site visit; 150-gal propane tank adjacent to Building 922.

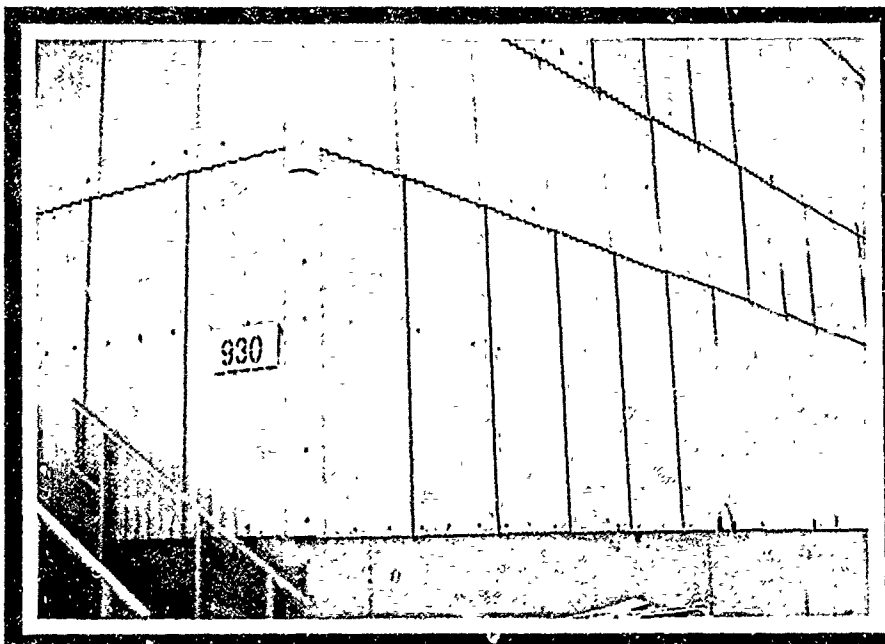
42. GENERAL CONDITION OF TRANSITE SIDING

- Asbestos - numerous onsite buildings constructed with Transite siding and other asbestos-containing material. Some siding material is broken along the lower side of buildings.

Wipe, destructive, and dust sampling of building interiors is recommended for most of the primary ESOs discussed in Section 3. The presence of asbestos materials in certain buildings in the Phase II area has been confirmed by previous sampling, therefore, sampling for asbestos is recommended only for Phase III buildings.

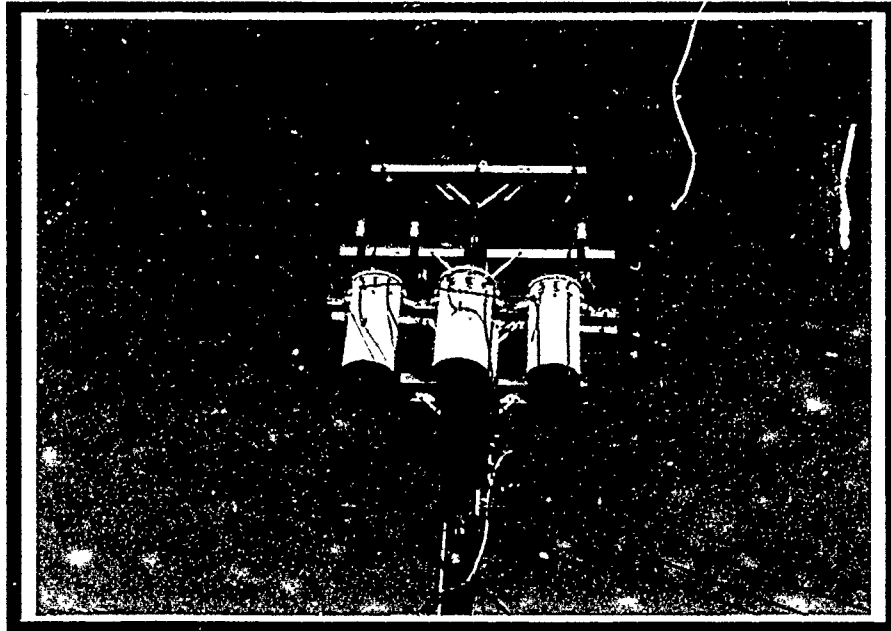
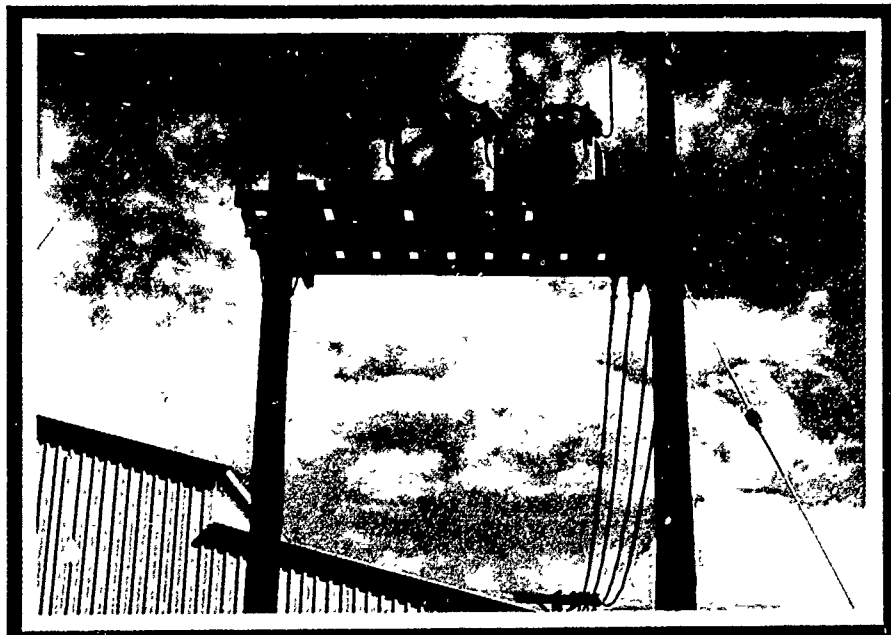
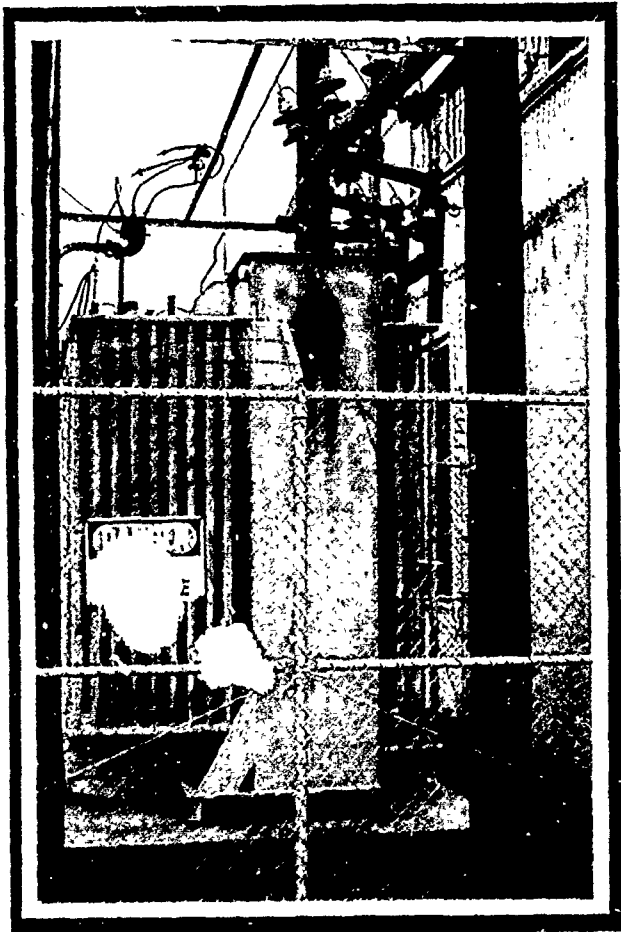
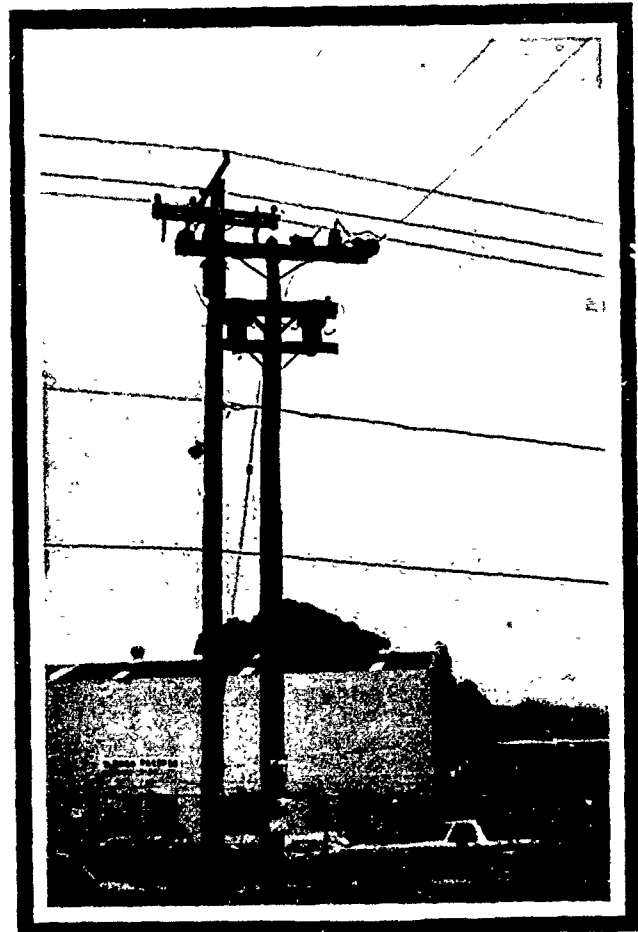
TRANSFORMERS

- Transformers - approximately 40 transformers, two pad mounted, the remainder pole mounted. Fluids have not been tested for polychlorinated biphenyls (PCBs) content. Two apparent minor leaks observed.

All transformers on the property potentially contain PCBs and two of them appear to have leaked in the past. An inventory should be made of all transformers remaining on the property (except Phase I), and each transformer should be sampled for PCBs.
